ALTOONA WATER AUTHORITY

ENGINEERING REPORT

EVALUATION OF MILL RUN DAM

SEPTEMBER 2010

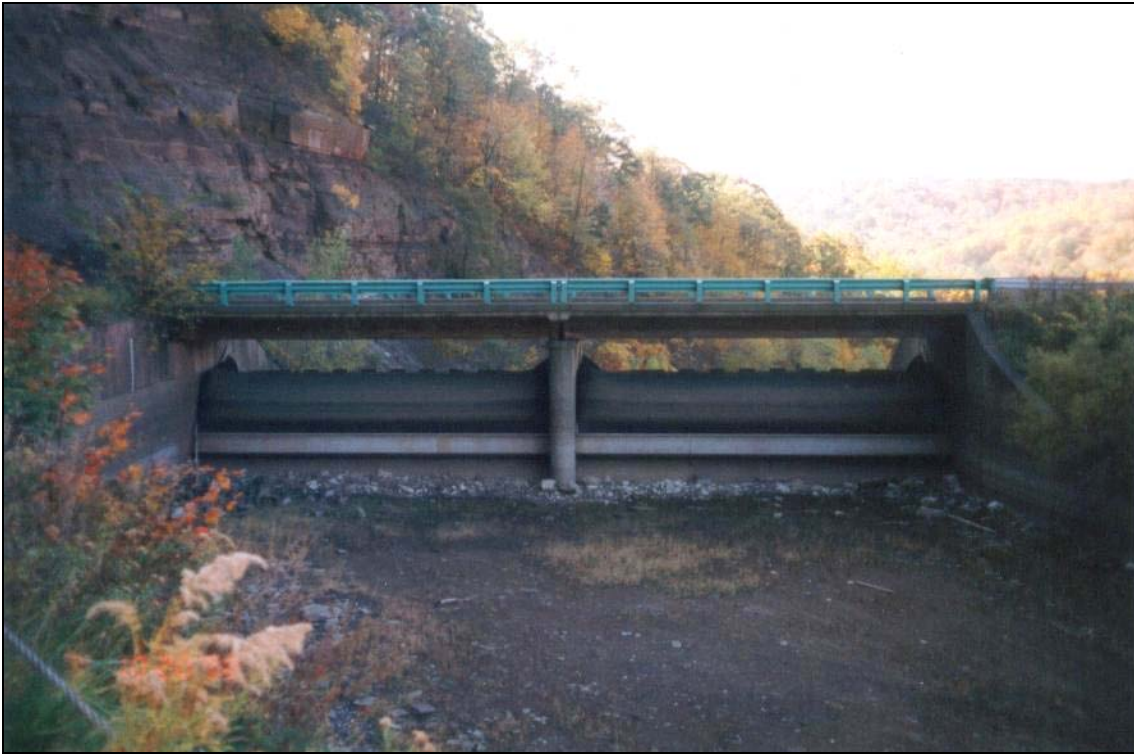
However, supply water take-off often exceeds inflow and the pool is maintained below the spillway crest. Also, the rubber dams have not been operationally reliable, tending to sag at times and allowing storage to be lost downstream. Finally, the Mill Run water treatment plant is shut down periodically for reservoir management purposes. The net effect is that the dam is generally operating at or below the original pool level of El. 1502.

Figure No. 4: Upstream View of Rubber Dam and Bridge

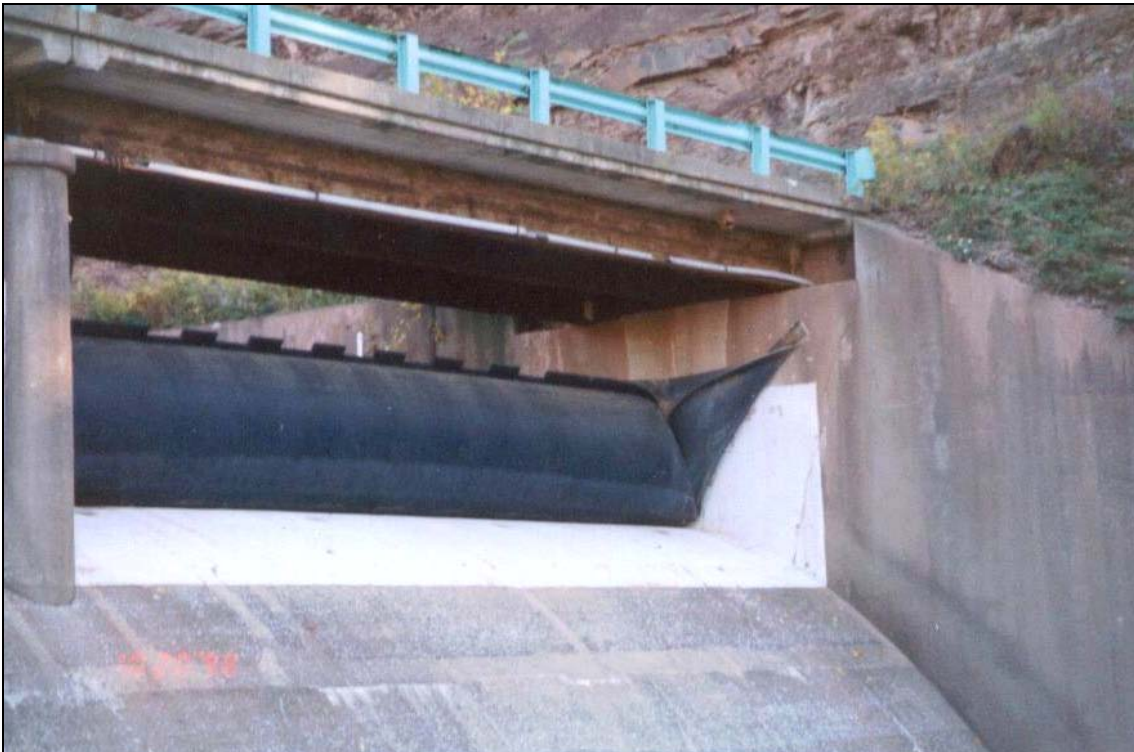
Figure No. 5: Downstream View of Rubber Dam and Bridge

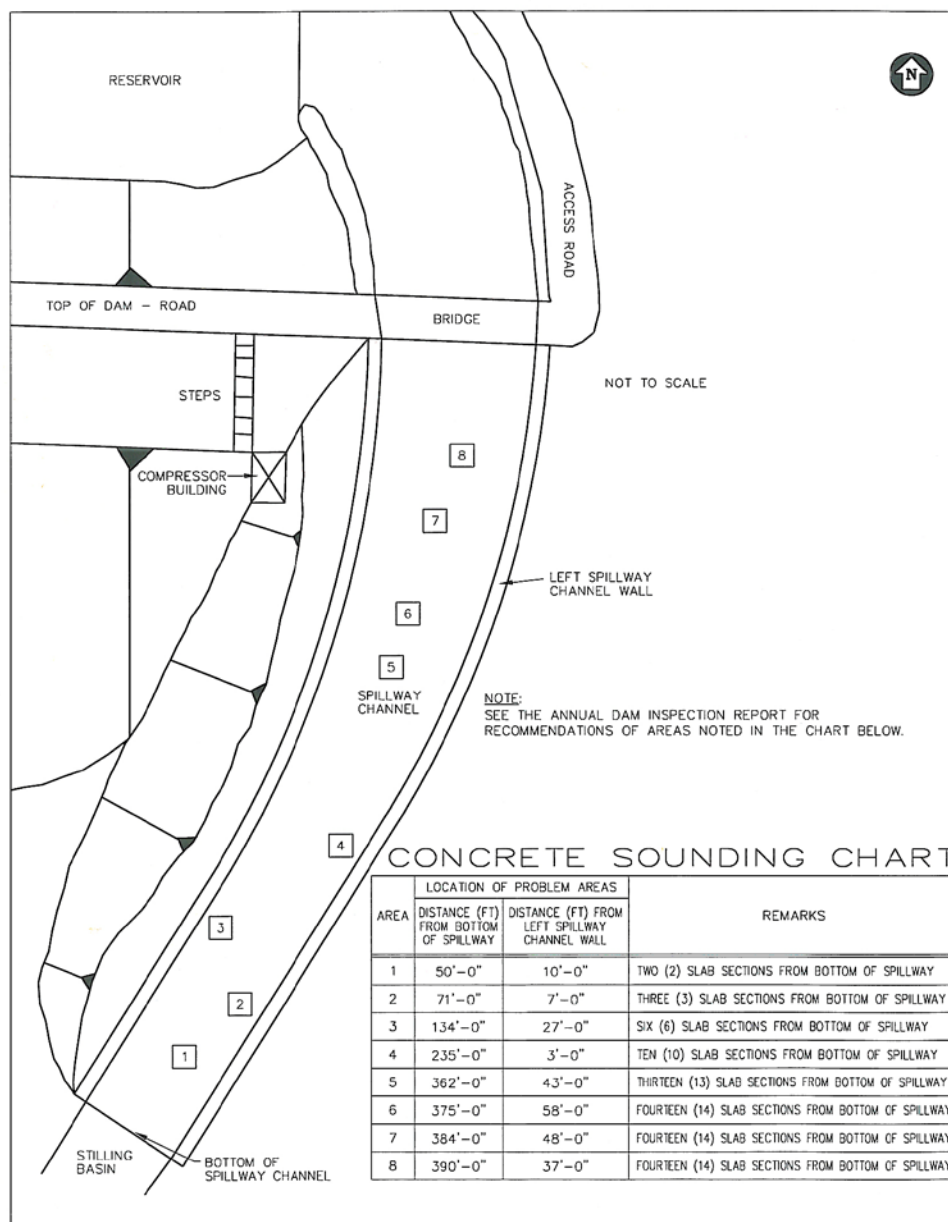
- **Spillway** - In 2001 and 2002, the reinforced concrete spillway was examined using a percussion sounding tool (Delam 2000). The purpose of this testing was to find any voids existing under the spillway floor. Six (6) areas were found to have some void potential according to the following plan. These voids were likely caused by erosional underflow. It was recommended that the voids be filled with concrete. Non-intrusive techniques, such as injection grouting (cement or epoxy), could also be effective. This condition has existed for at least 10 years. Please refer to the attached figure.

Figure No. 9: 2001/2002 Concrete Integrity Testing

The spillway joints have been eroded at the slab sections and most of the joint filler has been eroded. The surface of the concrete floor is poor, with aggregate exposed along the entire channel. Cracking is evident in many of the floor slabs.

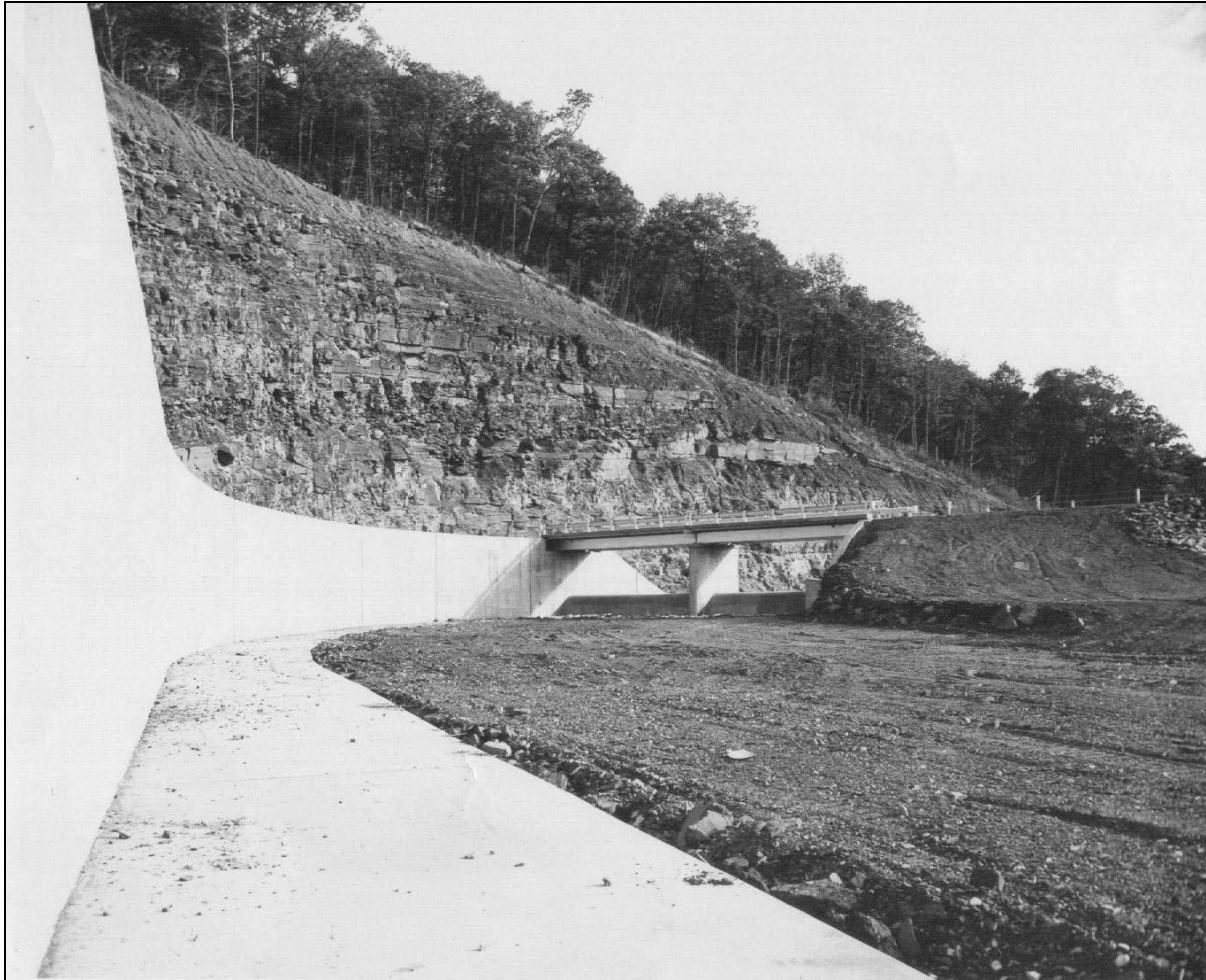
It is not known if a rock slope stability analysis was performed based on the test borings or other observations. The jagged, overbroken appearance of the rock face after construction (See Figure No. 33) shows that no pre-splitting blasting was performed. A smoother rock face would have resulted in less exposure to weathering of erodible beds (siltstones/mudstones).

Figure No. 33: Left Abutment Rock Slope from Spillway Approach Channel (1958)
(Note Jagged/Overbroken Rock Slope Face)

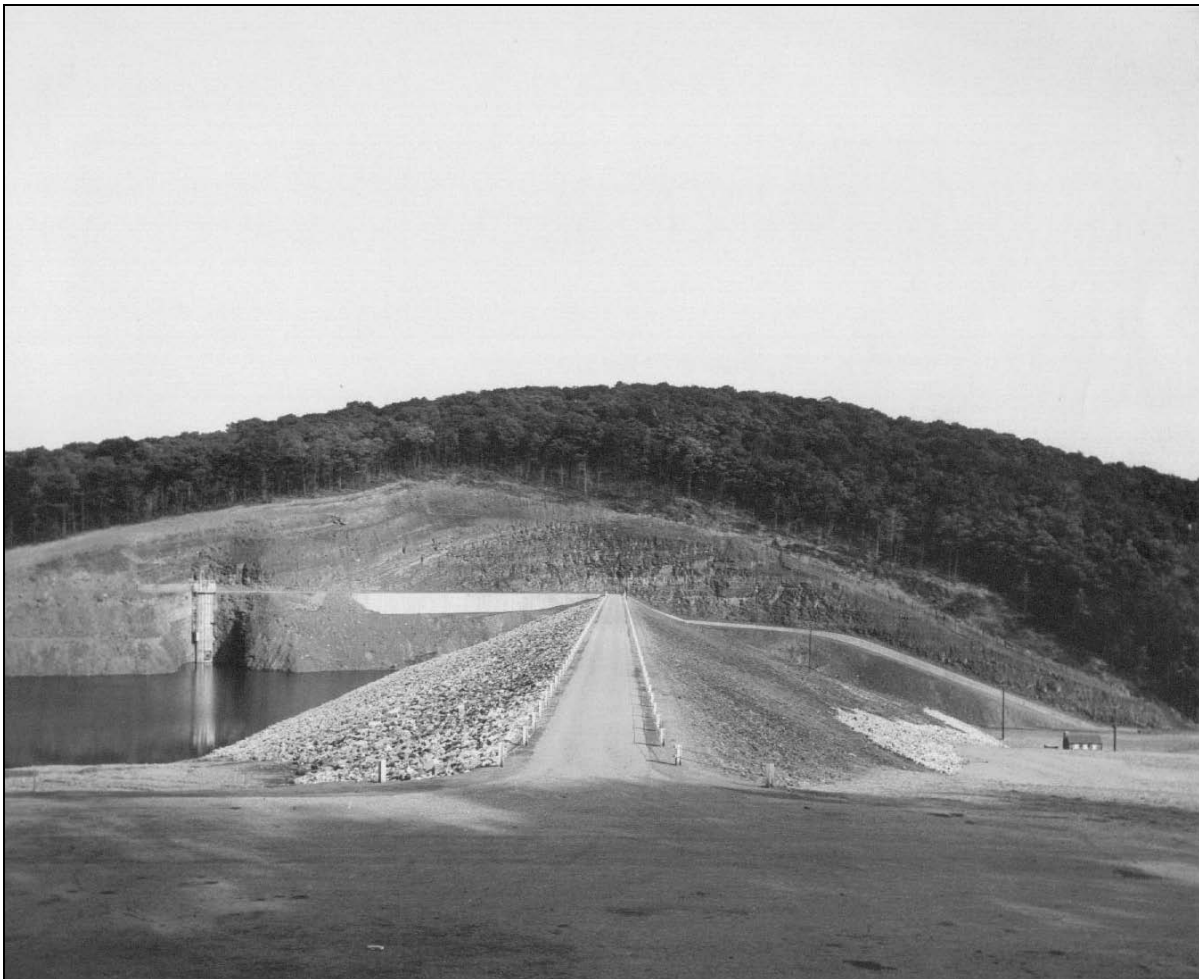
It can be inferred from these reports that the dam is founded on a heterogeneous bed of mudstones and siltstones with interbedded sandstone features. The beds dip under the dam toward the reservoir and have generally low permeability. The report does not provide detailed slope stability conclusions. Please refer to the following Figure 35 for the geologic map for the site area.

**Figure No. 34: Rock Slope from Right Abutment Along Dam Axis
(Note Dip of Beds Upstream and Flat Beds Downstream)**

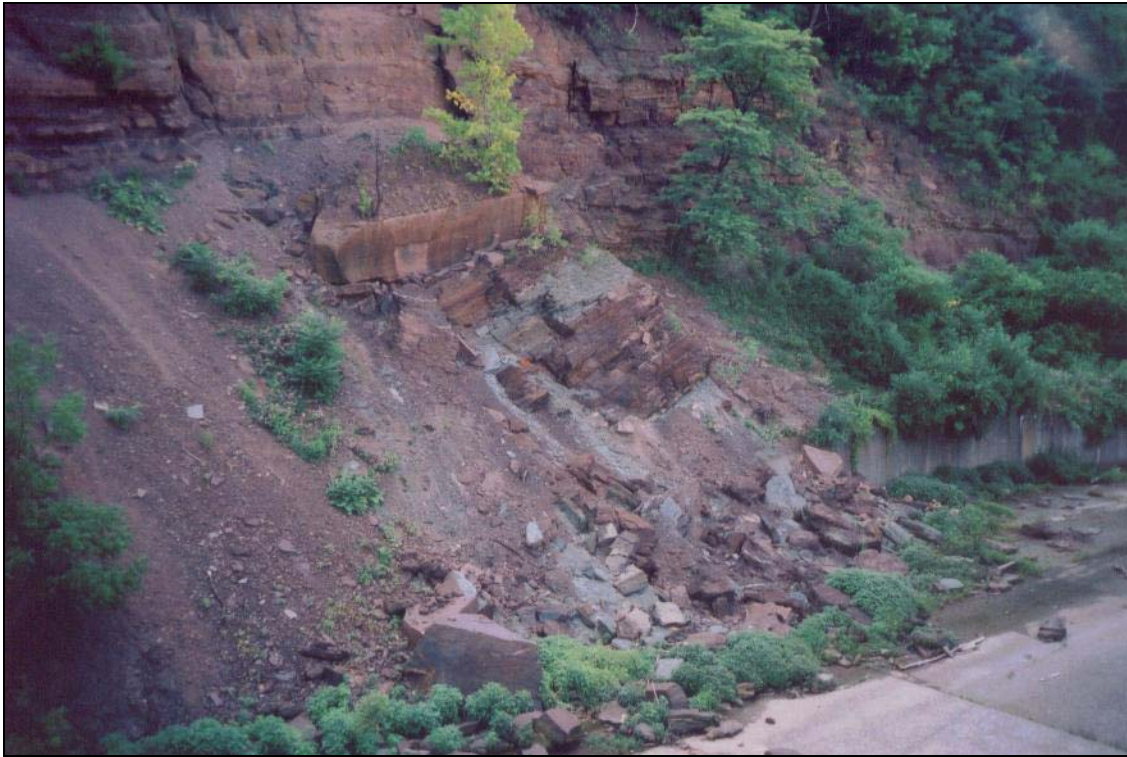
- Farther down the spillway cut, bent trees are evidence of a possible colluvium boulder slide developed by a fault. This rock mass may have been undercut by the original spillway excavation, thus causing a gradual creep of the slope. Above this area, rock shows deeper weathering with red/brown clay color and rock fragments. The whole slope is creeping downstream as evidenced by sandstone boulders on the slope and random sandstone slabs on-end. A creeping, talus/colluvium slide mass is pointed downstream from just below the slide area towards the stilling basin.

Figure No. 36: Rock Slide (2005)

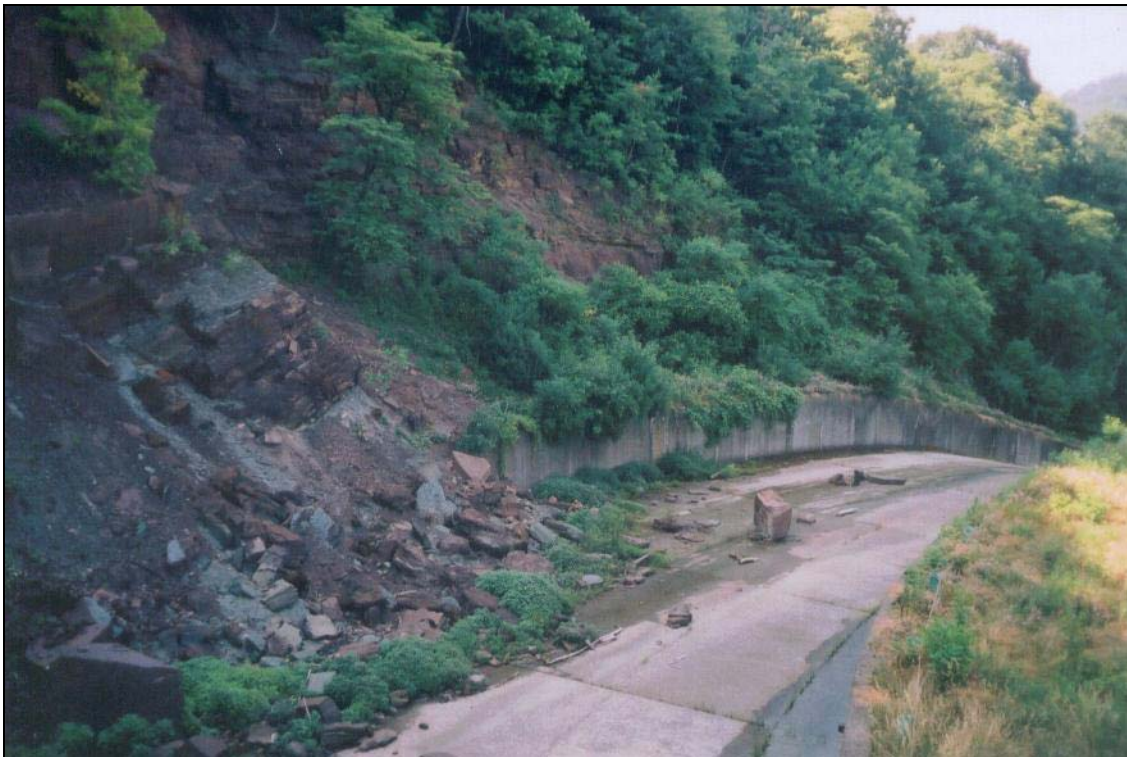
Figure No. 37: Rock Slide (2005)

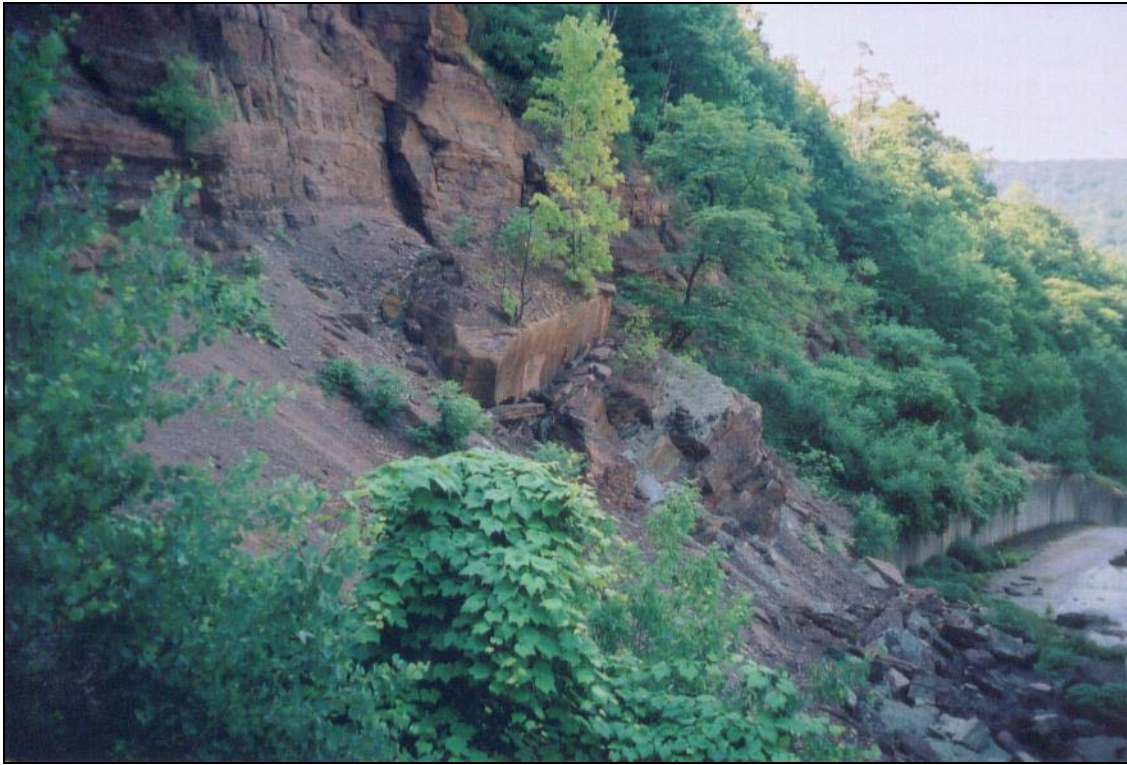
Figure No. 38: Rock Slide (2005)

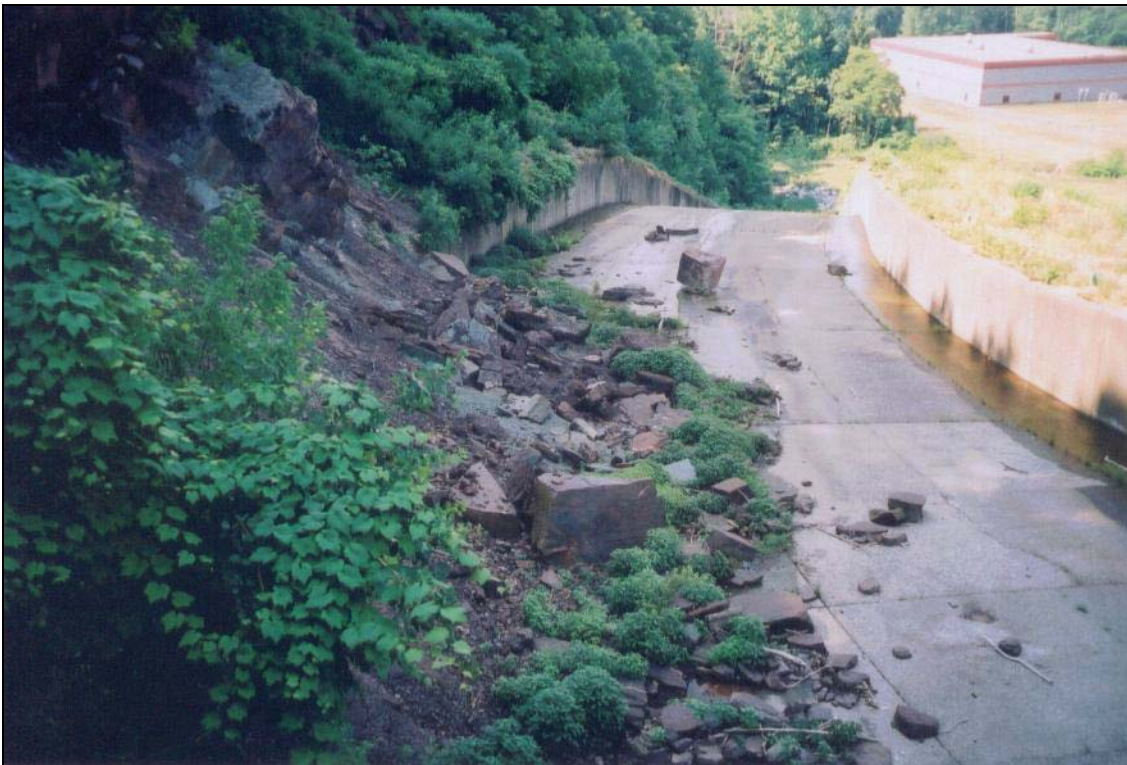
Figure No. 39: Rock Slide (2005)

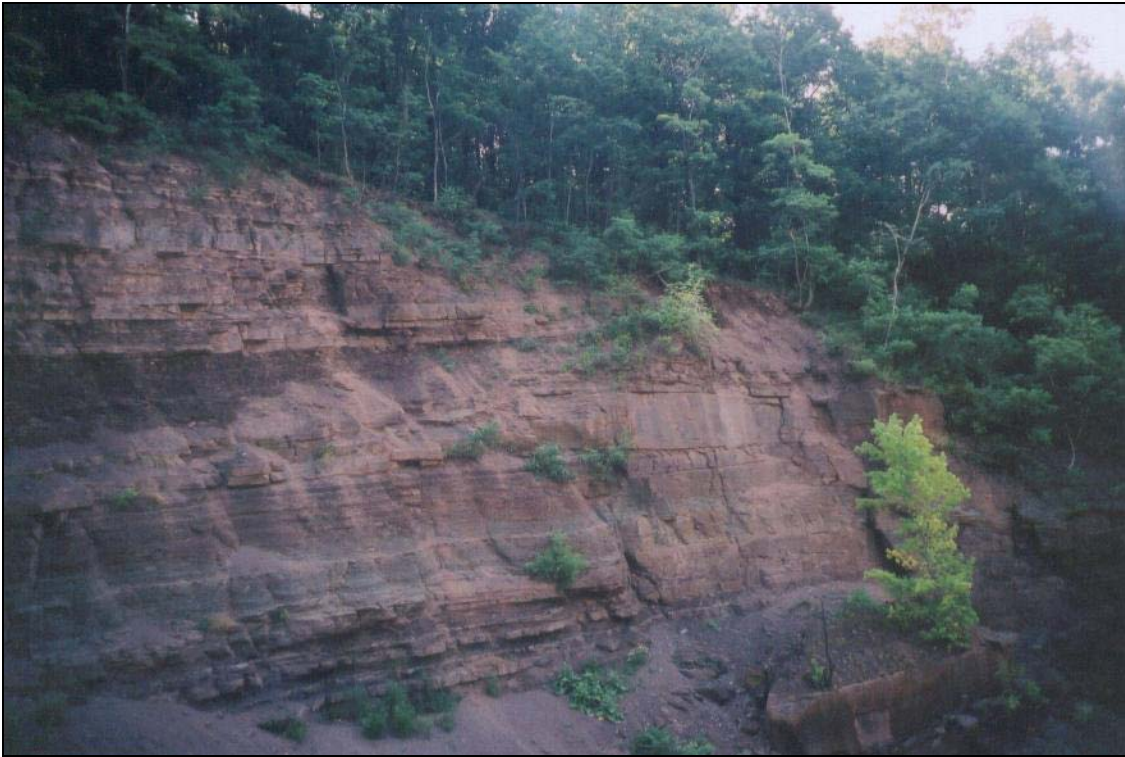
Figure No. 40: Rock Slope Above Slide Zone (2005) Toward Axis of Dam

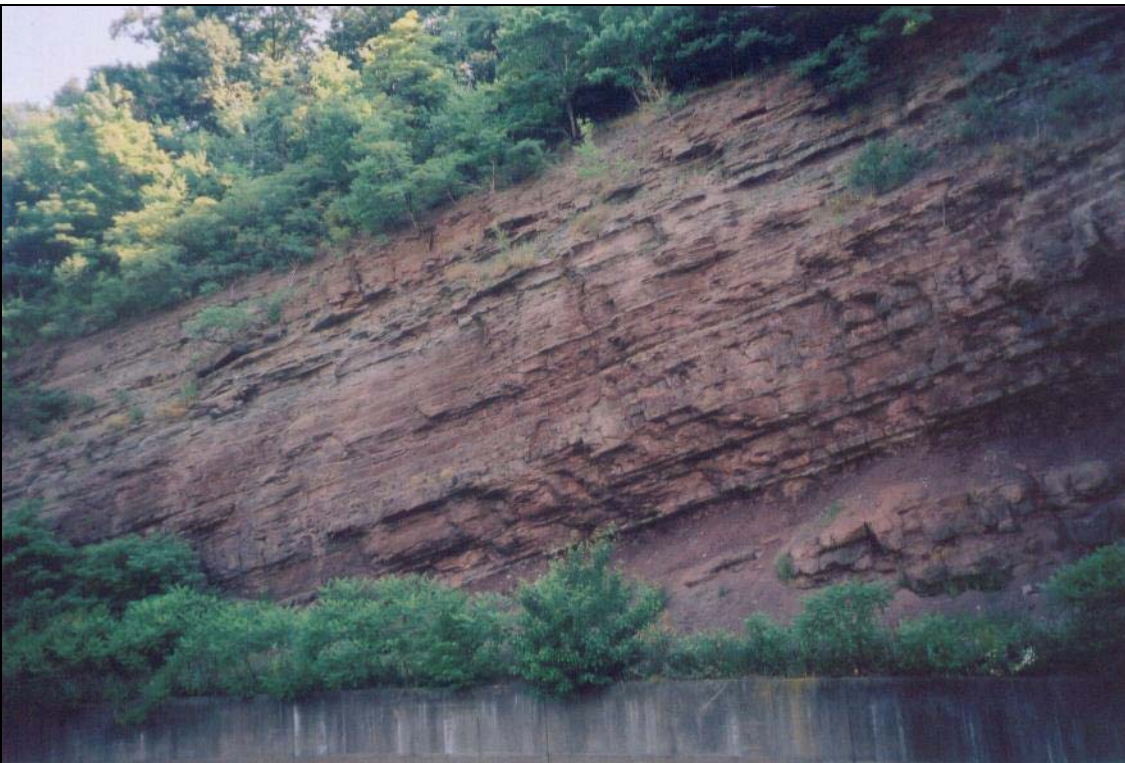
**Figure No. 41: Rock Slope Upstream of Dam Axis (2005)
(Note Dip of Beds (12° - 15°))**

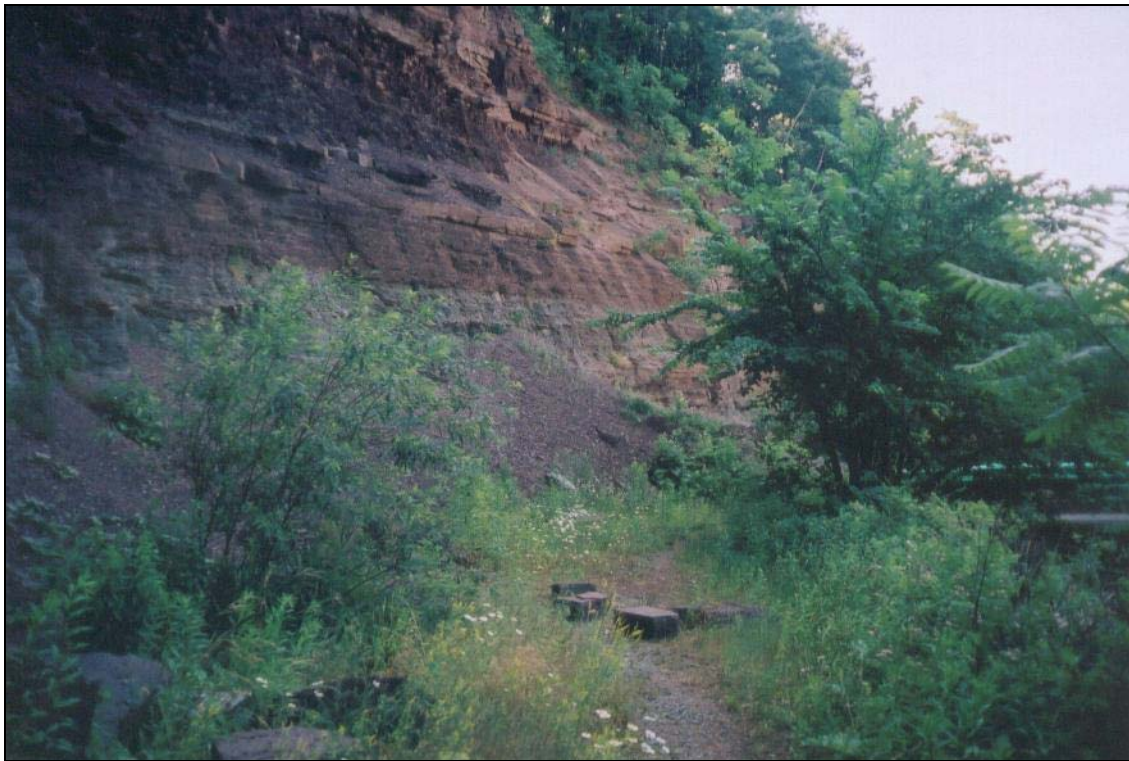
Figure No. 42: Rock Debris on Access Road at Axis of Dam

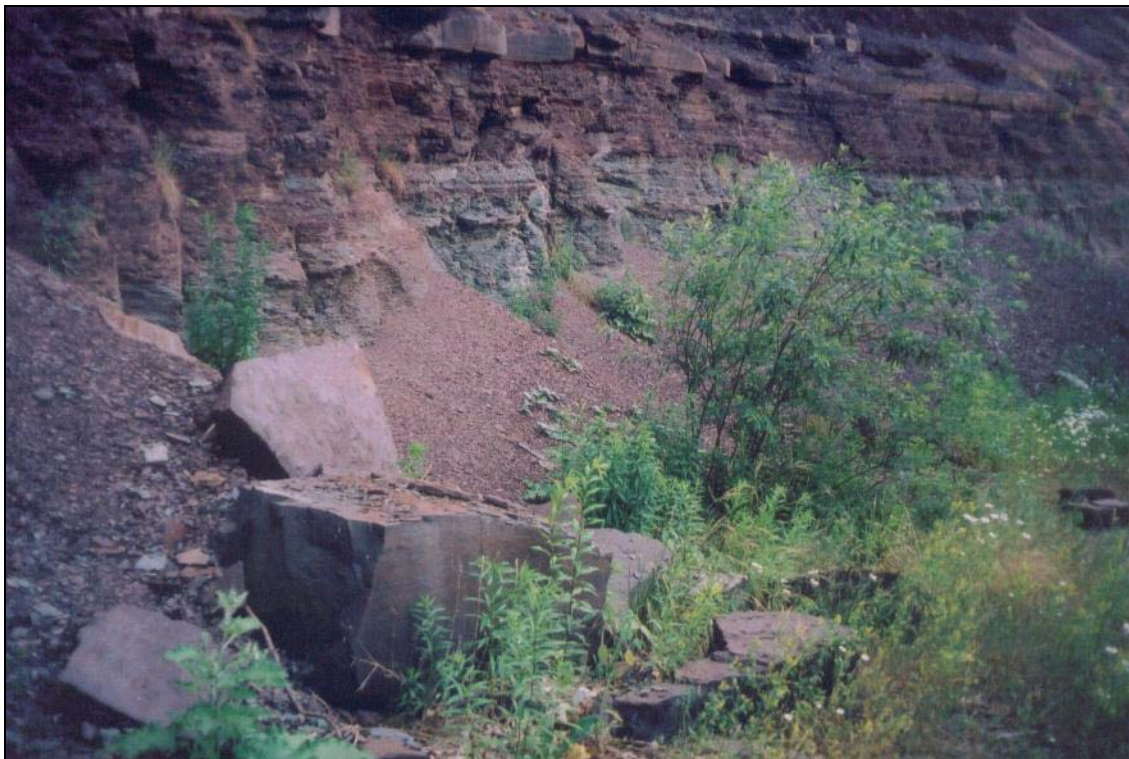
**Figure No. 43: Rock Fall & Debris Above Axis of Dam
(Note Weathering)**

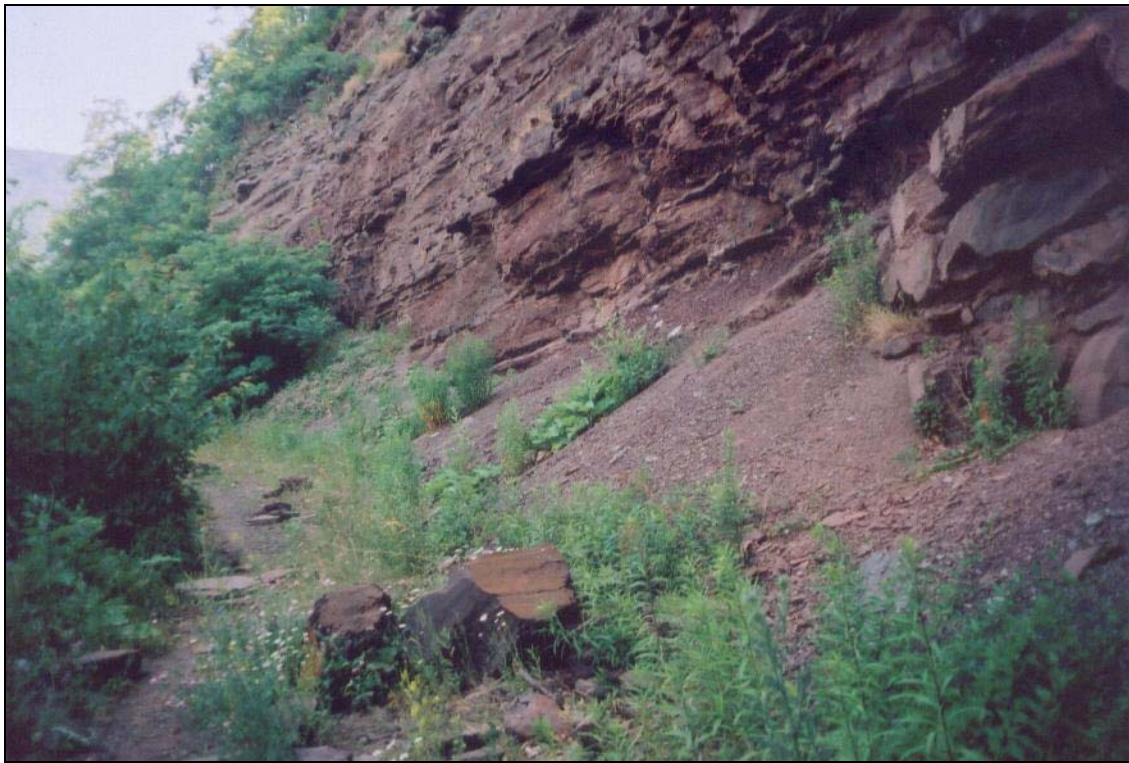
**Figure No. 44: Rock Fall & Debris Along Access Road to Intake Tower
(Note Weathering Under Sandstone)**
