ALTOONA WATER AUTHORITY

ENGINEERING REPORT

EVALUATION OF MILL RUN DAM

SEPTEMBER 2010

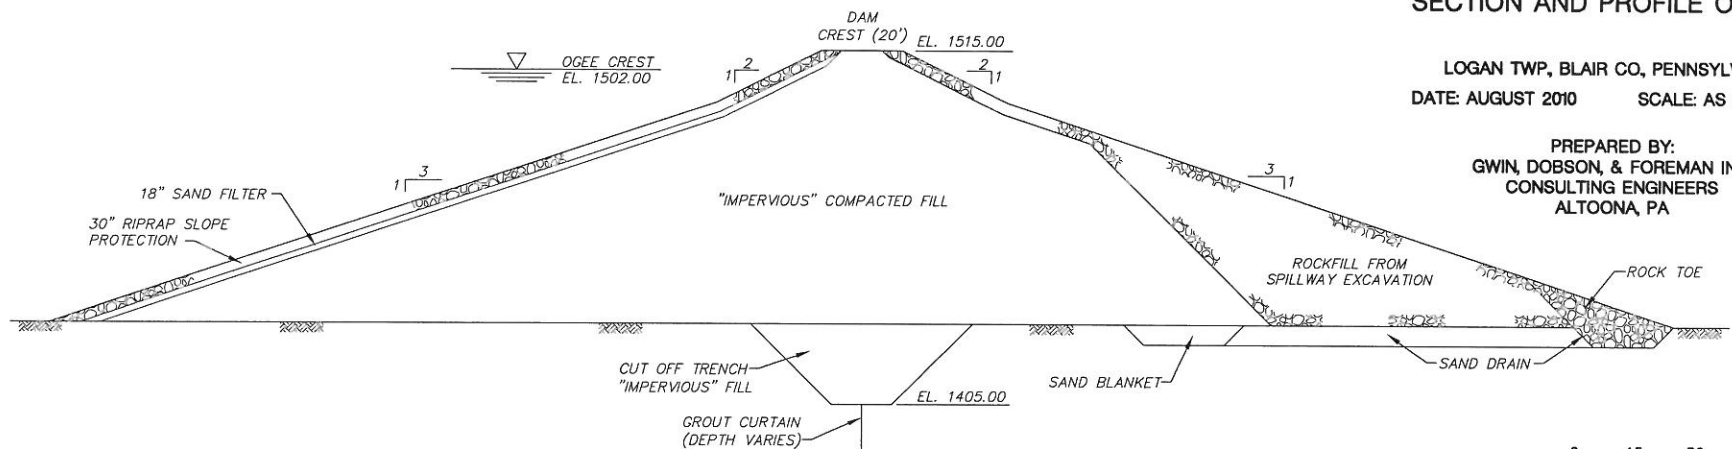
TYPICAL CROSS SECTION OF EXISTING DAM

Embankment - The dam was designed as a zoned embankment. It consists of a compacted impervious upstream fill with a large rock-fill section forming the downstream slope. See typical cross section, Figure 3. The impervious section extends over a cutoff trench excavated into foundation rock at the center line of the dam. A longitudinal sand drain is located near the downstream limit of the impervious zone. This sand drain is connected to two (2) transverse sand drains which discharge into a rock-fill trench at the toe of the dam. A toe drain system collects seepage for discharge to a blow-off channel.

The design incorporated such basic components as zoning of the embankment, cutoff trench, foundation grouting and internal drainage system. However, there is no filter zone between the downstream rock shell and the impervious core. Internal drainage is provided by a longitudinal sand drain at the downstream toe of the impervious zone and by the downstream rock zone.

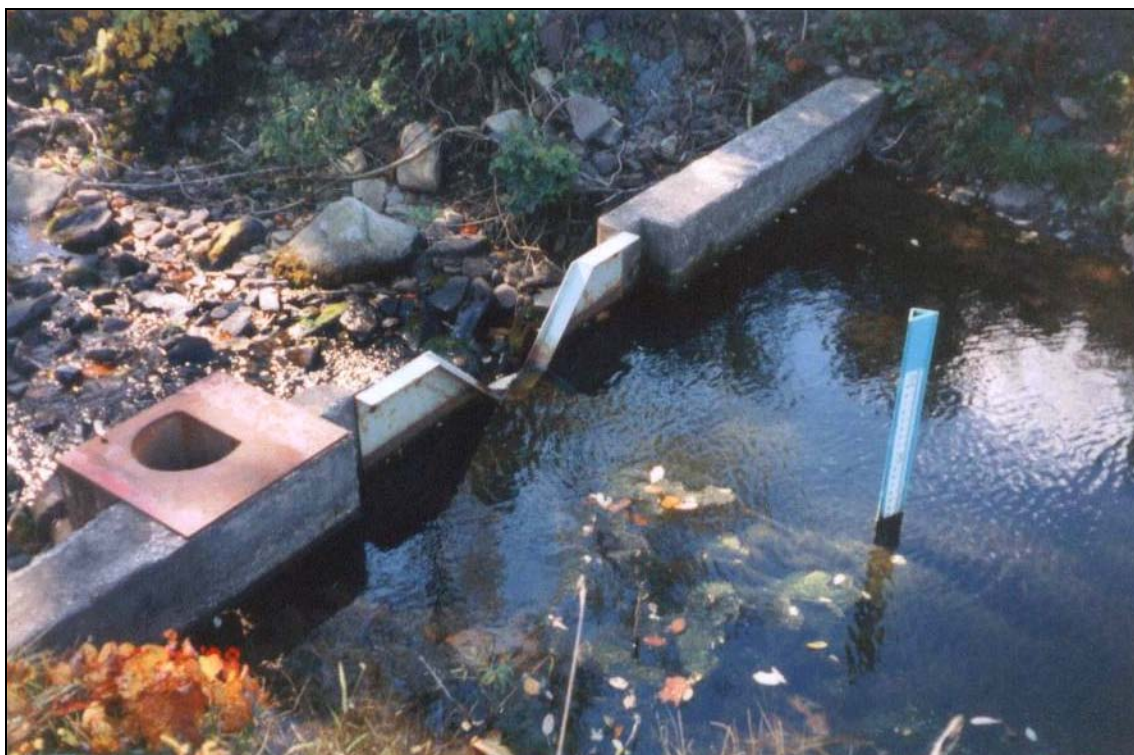
Figure No. 6: V-Notch Weir in Blowoff Channel

- **Subsurface Drainage/Seepage** - Seepage from the dam foundation and embankment has been controlled by an internal sand blanket and collected downstream in a toe drain system. The volume of seepage has been a concern at times. In fact, shortly after filling of the dam, seepage quantities of 200-250 gpm caused some anxiety for City and Authority officials. However, the design engineers stated that the seepage was not excessive. In 1958, drainage pipes were installed along the downstream toe to collect the seepage flow from the sand filters for discharge to the blowoff pipe channel. Before Authority operation, the City Water Department stated that seepage flow averaged about 200 gpm. At the time of the Phase I inspection (July 10, 1978), the seepage flow was 165 gpm with the reservoir four feet below the spillway. Generally, seepage has varied between 75-250 gpm, depending on pool elevation. The flow is clear with little if any turbidity. However, inspection personnel suspect these pipes are clogged or collapsed due to several wet areas downstream.

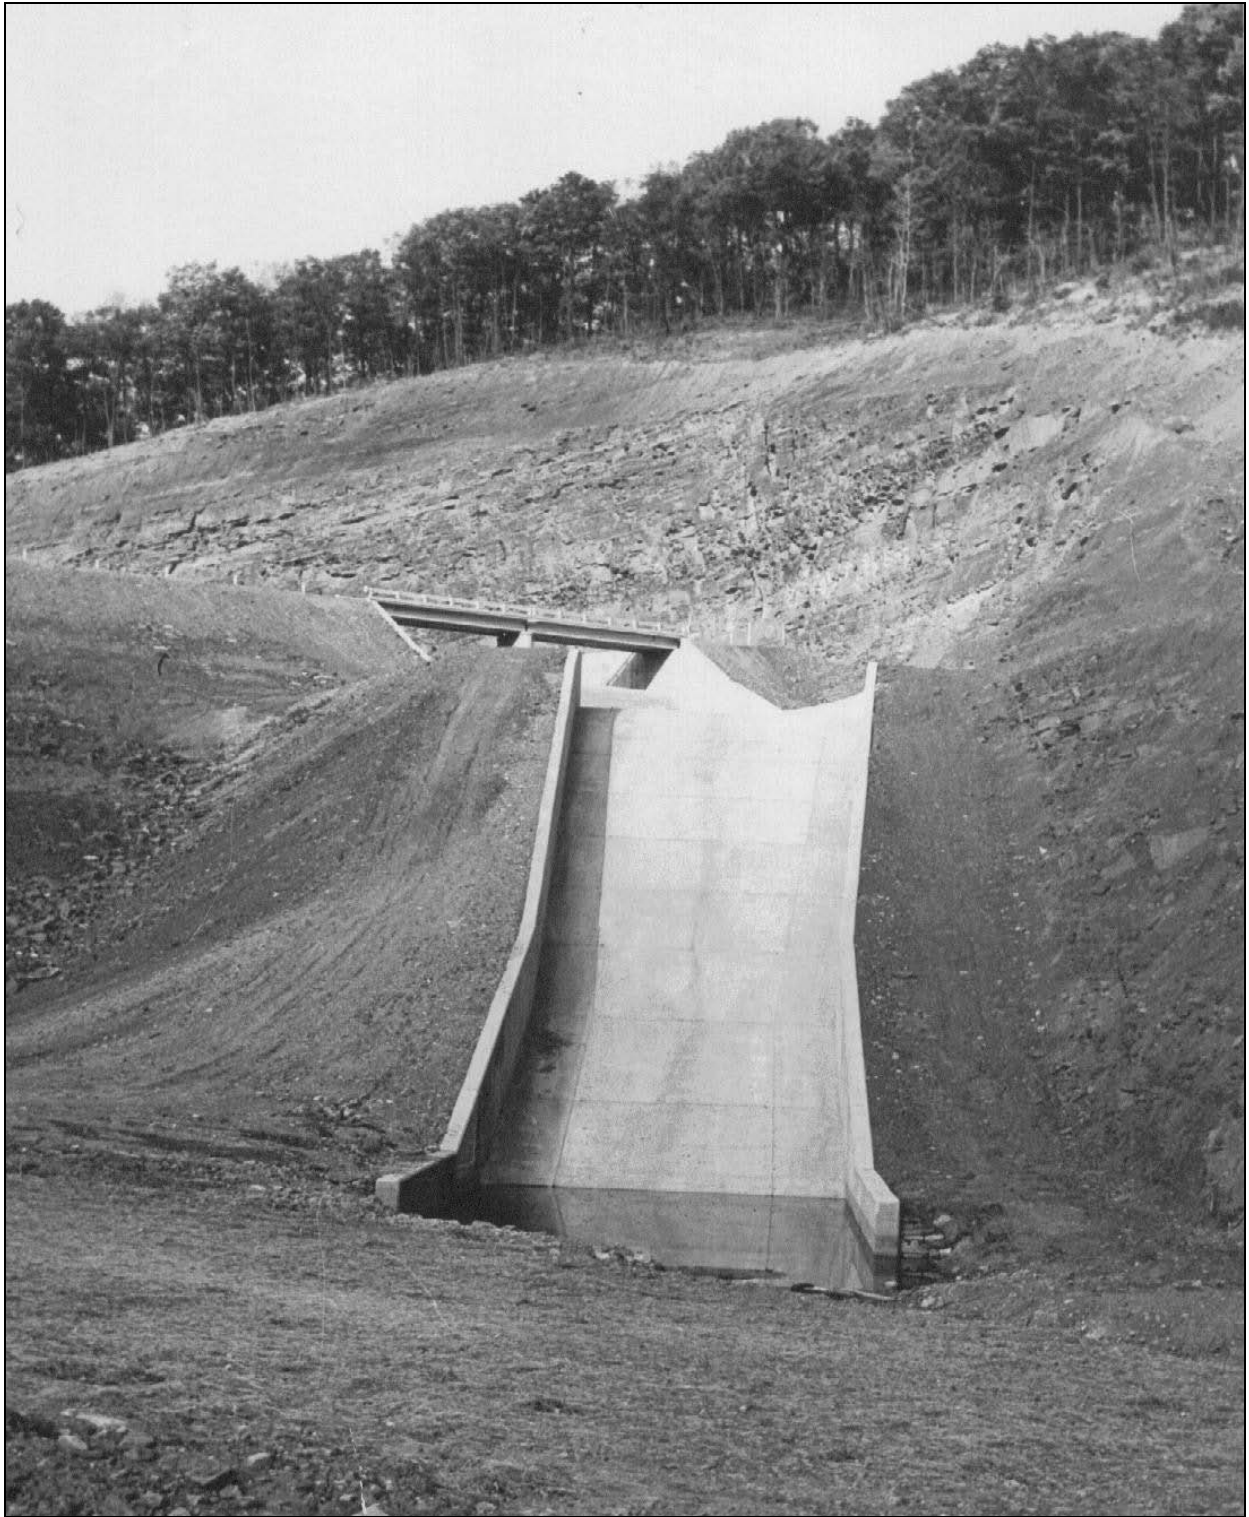
Figure No. 27: Spillway Chute (1958)

- This option necessitates optimum rock slope stability along the spillway channel. Because of the proximity to the rock slope, a massive "block" failure (which could fill/damage the spillway) cannot be dismissed. More sophisticated slope stability techniques may be necessary than a simple slope "lay back." Please refer to Figure 27 for the 1958 photo of the spillway.

Our analysis of the existing spillway shows that the current spillway alignment is not the most hydraulically efficient or economic solution. Although this structure is largely founded in rock, the curvilinear alignment has the potential to form standing waves. The required radius to provide cross-wave cancellation in a supercritical flow regimen may be impractical from a cost standpoint.

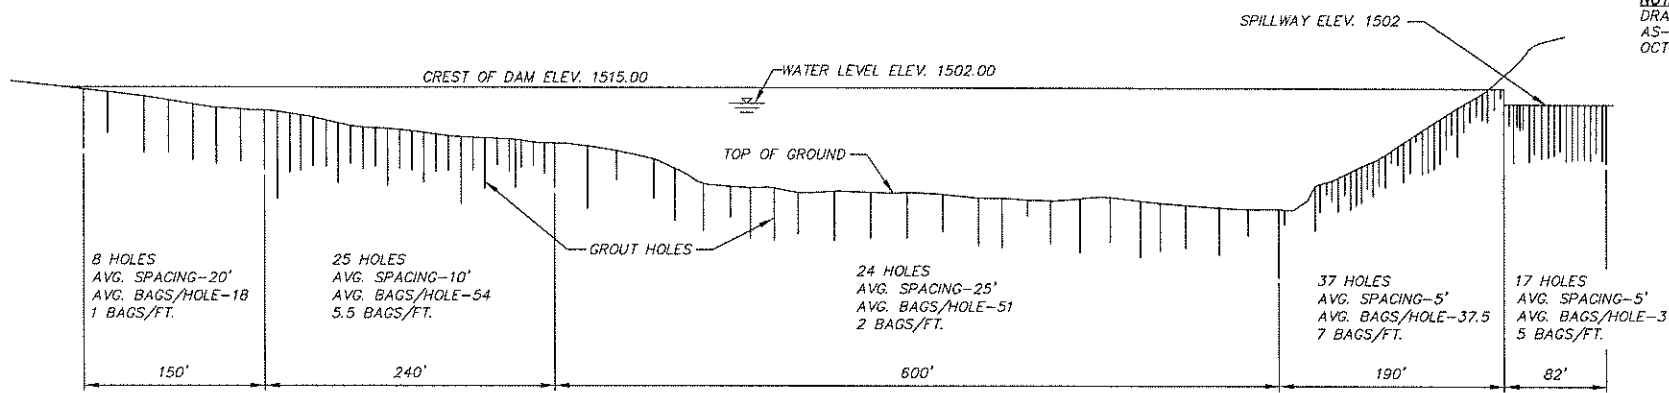
FIGURE No. 32
FOUNDATION GROUTING
AND PHREATIC SURFACES

Seepage Calculation - A preliminary assessment of seepage volume was computed on the basis of a flow net and parabolic curve (after Casagrande) calculations. Assumptions were made for soil permeability. A range of 250 to 350 gpm has been computed for a soil permeability coefficient ("K") of 0.0015 cm/sec. Although many variables are involved and certain simplifications were made, our calculation of seepage flow seems to agree with historical observations. Therefore, given the height and length of the dam, embankment material, methods of construction and drainage control system, the seepage flow does not appear to be excessive. In fact, this seepage comprises most of the required conservation release for Mill Run dam (323 gpm or 0.466 mgd). Please refer to the Appendix for seepage computations.

No further recommendations are offered for seepage control at this time other than continuous monitoring and observation by operating personnel and installation of a new toe drain at an estimated cost of \$125,000.

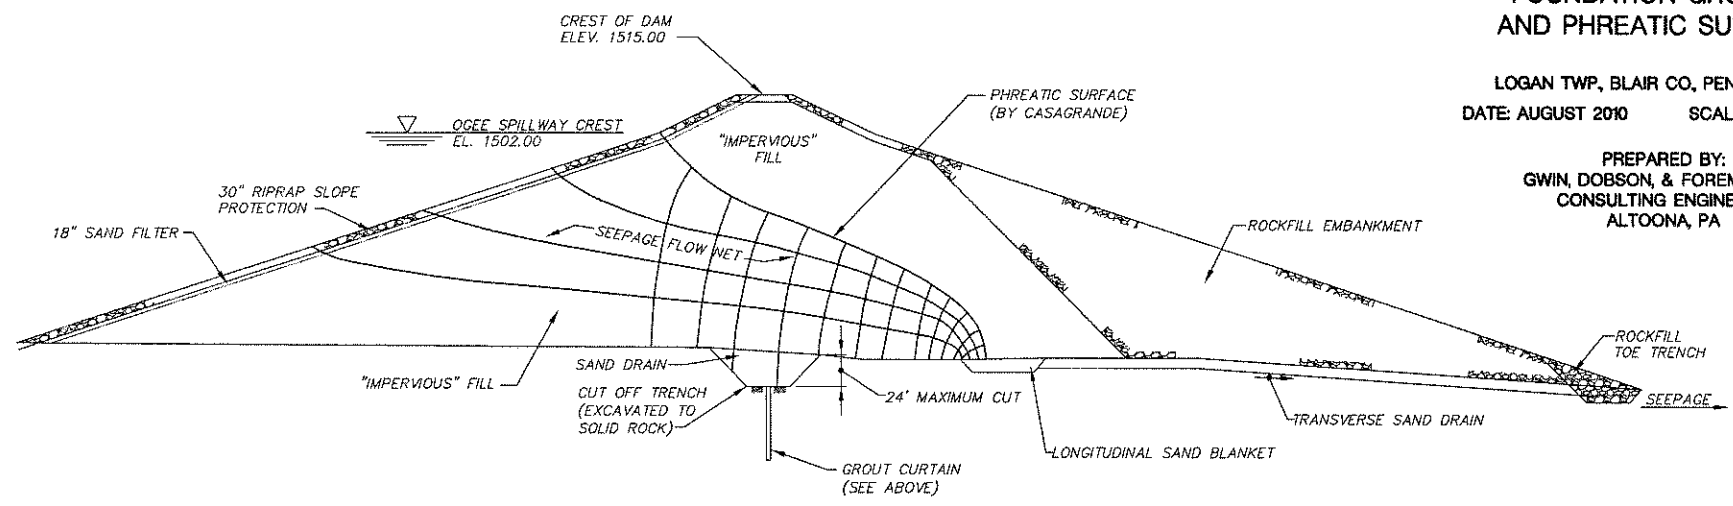
DAM EMBANKMENT PROFILE AND PHREATIC SURFACES & SEEPAGE FLOW NET
NOT TO SCALE

Preliminary Evaluation of Slope Stability - Both the upstream and downstream slopes have a factor of safety greater than 1.5 when evaluating the presumed, existing conditions (normal pool). The upstream slope value is 1.616 and the downstream safety factor is 1.794. When the phreatic surface is raised six (6) feet (inflation of rubber dam) the factor of safety values actual increases for both the upstream and downstream sections due to pore water pressure. However, seepage flow should increase due to the increased hydraulic head.

The only direct concern is during a "rapid drawdown" condition. Evaluating the upstream slope during rapid drawdown indicates that if the impervious fill material is undrained and cohesionless, the safety factor is less than unity (0.924) and may be indicative of a potential sloughing condition. However, if the impervious soil is assumed to have a cohesion value of 200 psf (as indicated in the report), the embankment would be considered stable (FS = 1.173). Please refer to the Appendix for stability analysis calculations and computer output for more information.

Our conclusion is that the original stability analysis was confirmed (F.S. = 1.5) if assuming, steady state conditions (i.e., reservoir at normal pool). Obviously, this is further confirmed by the fact that no evidence of slope failure has ever been observed. However, the rapid drawdown condition is considered the most critical failure mode for earth embankments. In this failure modeling condition, the safety factor is below 1.0. Therefore, consideration should be given to obtaining in-situ soil samples, performing soil testing and modeling an updated stability analysis during the design stage.

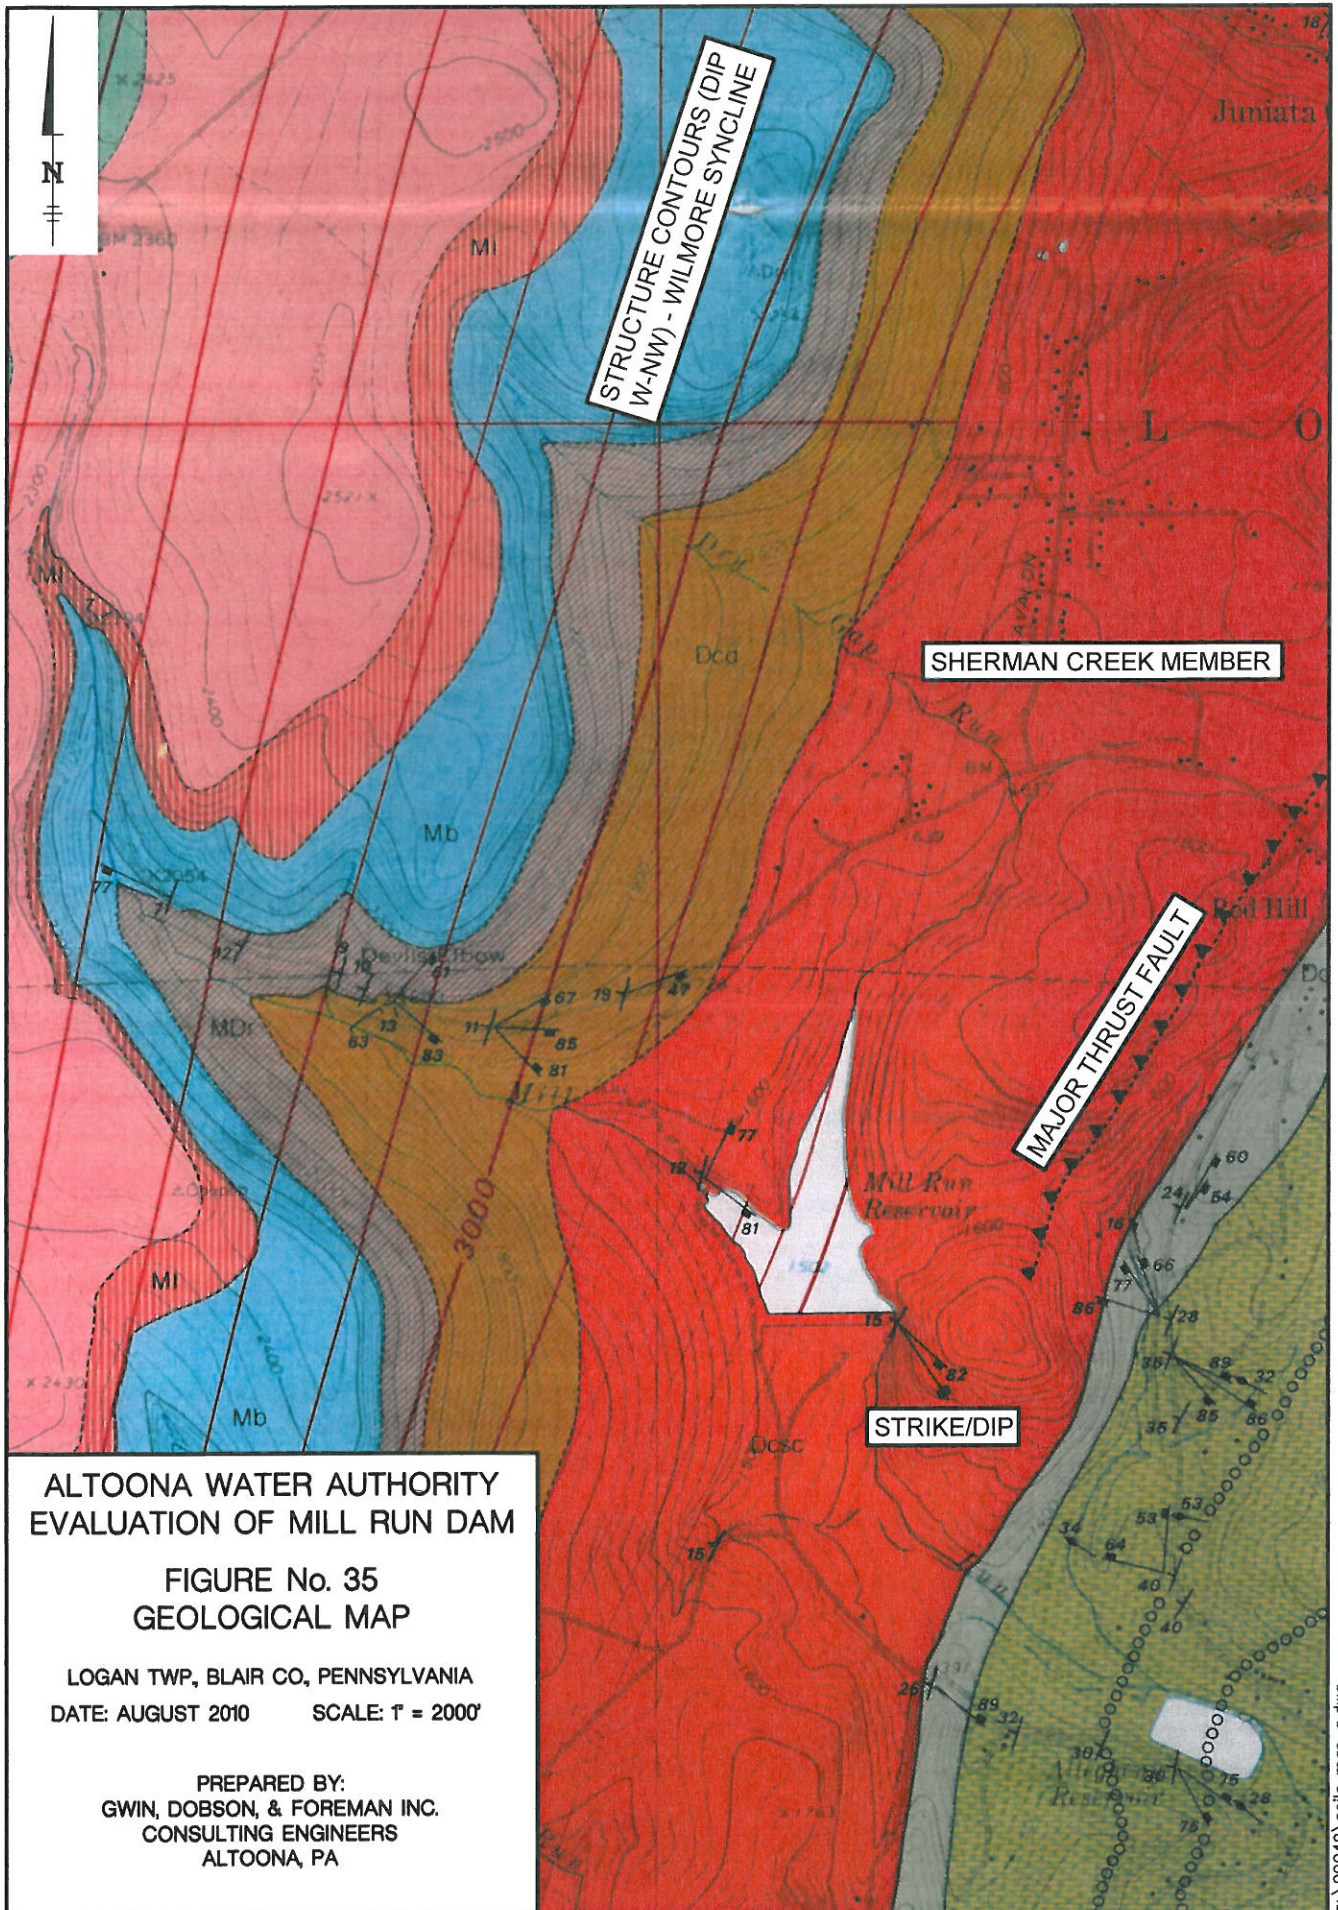
Concerning structural geology, Mill Run dam is located on the southeastern limb of the Wilmore Syncline. A syncline is a fold of layered rock in which the layers dip toward the hinge; it is concave upward (like a bowl). This condition is opposite to the anticline which is a subsurface "dome" structure. A strike-and-dip measurement was taken at the east abutment. The beds dip to the northwest 15° (toward Buckhorn mountain) at a strike of N 40° E. A major thrust fault was inferred (or estimated) about 1,200 feet east of the rock slope. A thrust fault is defined as a "hanging" wall (upper block) which has moved or "thrust" upward over the "footwall." Concerning fractures, measurements were taken at the rock face showing an 82° dip to the southwest on a NW to SE strike (See Figure No. 34).

**Figure No. 34: Rock Slope from Right Abutment Along Dam Axis
(Note Dip of Beds Upstream and Flat Beds Downstream)**
